Manhole Inspection Summary

Manhole # S39K__016MH

Insp Date: **8/20/08 2:19 PM**

Location Address: **pier 5**

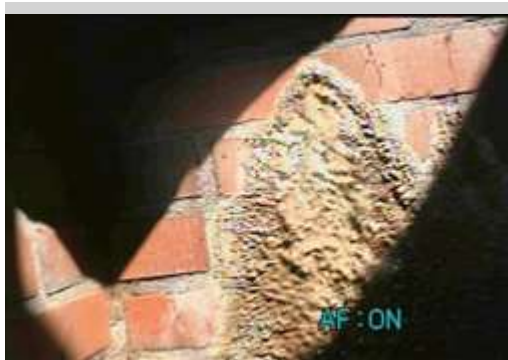
Defect 2

Infiltration: ☐ None ☐ Joint ☐ Cracks ☐ Mortar ☐ Roots ☒ **Wall**

infiltration barrel

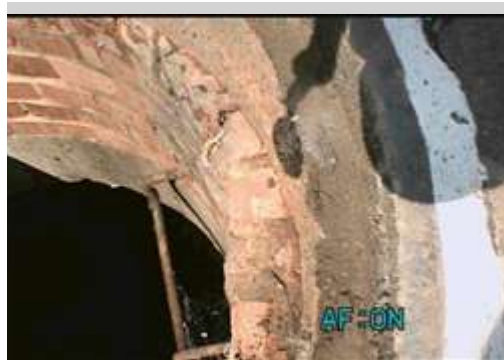
Defect 1

Offset: **2.5** (in.)

Condition: ☐ Sound ☐ Cracked ☐ Root Intrusion ☒ **Loose Brick** ☐ Deteriorated

Count: **1** Missing: **0** ☒ **Corroded**

chimney loose bricks, frame offset, & step corroded

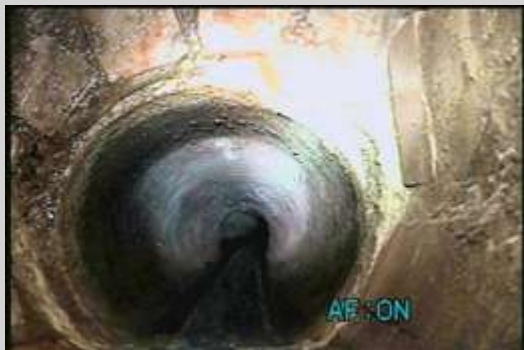
12 O'Clock Outflow

8 in. Circular Gravity Sewer
Pipe Out @ 12 O'Clock

Pipe Material: **Clay** ☐ Pipe Lined

Invert Depth: 6.60 (ft.) Flow Characteristics: **None**

Infiltration: **None** Pipe Seal Cond: **Unknown**

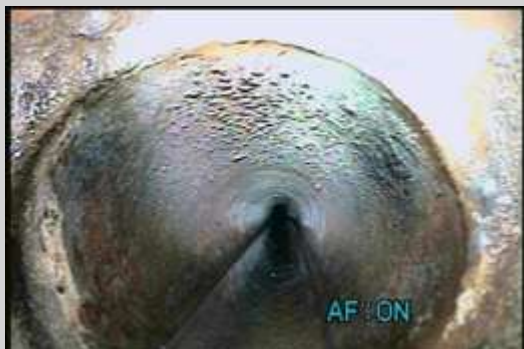
6 O'Clock Inflow

8 in. Circular Gravity Sewer
Pipe In @ 6 O'Clock

Pipe Material: **Clay** ☐ Pipe Lined

Invert Depth: 6.40 (ft.) Flow Characteristics: **None**

Infiltration: **None** Pipe Seal Cond: **Unknown**

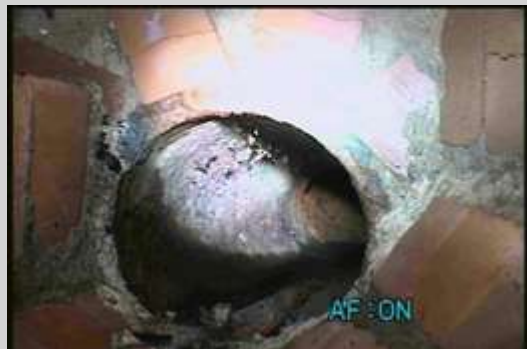
9 O'Clock Inflow

8 in. Circular Gravity Sewer
Pipe In @ 9 O'Clock

Pipe Material: **Clay** ☐ Pipe Lined

Invert Depth: **6.25** (ft.) Flow Characteristics: **None**

Infiltration: **None** Pipe Seal Cond: **Unknown**

Connects To: **Dead End**
